Cantilever steel post damaged by wind

An analysis for the cause of fracture failure of a cantilever steel sign post damaged by wind has been carried out. An unusual cause of failure has been identified, which is the subject of this paper. Microscopy and microanalysis of the fracture surface showed that the failure was due to pre-existing cracks, from the fabrication of the post. This conclusion was reached after detecting and analysing a galvanised layer on the fracture surfaces.

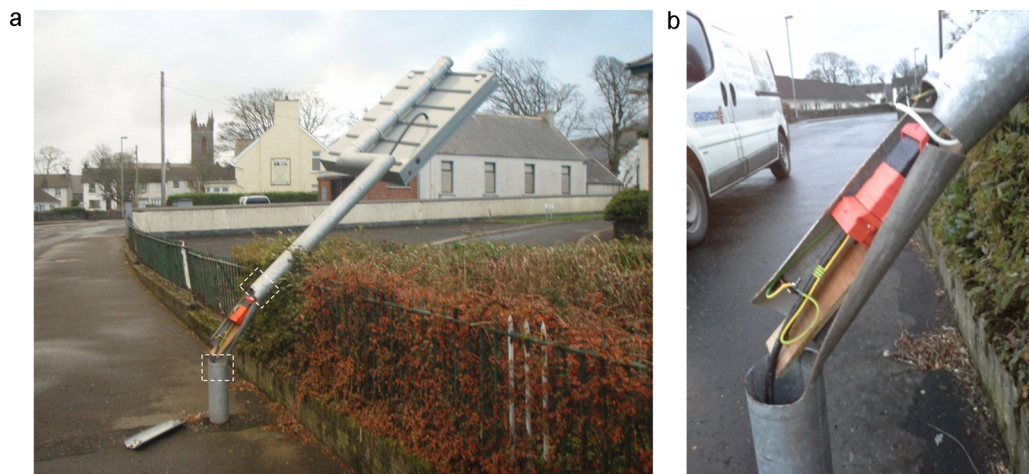
Bushmills Primary School, in Northern Ireland, has two electronic patrol signs (towards 100 kg each) on cantilever posts which were erected in November 2010. Over a period of time, the posts had been under a continuous swaying movement or vibration, caused by wind. Gusts and storms on 20 November 2013 caused one post to sheer in two places and fall with a consequence of blowing off the housing door. The post was situated in an exposed position. Fig. 1 shows the damage to the post. As can be seen in the photos, it broke at both the top and bottom of the aperture, at opposite ends. The post had an outer diameter of 142 mm, and a wall thickness of 4 mm. Luckily, the post fell outwards but live cables were exposed. The Department for Regional Development in Northern Ireland (DRDNI) was concerned about other similar cantilever posts and the appropriate Traffic Officers were made aware of this incident. This incident was reported through the procedures as set out in the health and safety manual used by DRDNI.

The post was then salvaged by cutting the remainder of the way through and removing the stump. The breaks are fairly straight and clean. The subsequent cuts show the marks of the angle grinder. The initial concern of the Roads Service is that this may be a fatigue failure due to cyclic loading within the design range rather than tensile failure due to the post being

Fig. 1. Damaged cantilever post (optical macro-photographs of the fracture site courtesy of the Department for Regional Development in Northern Ireland). (a) The two dashed boxes show the bottom and top tubes, cut off after damaging, for analysis; (b) overview of the fracture sites.

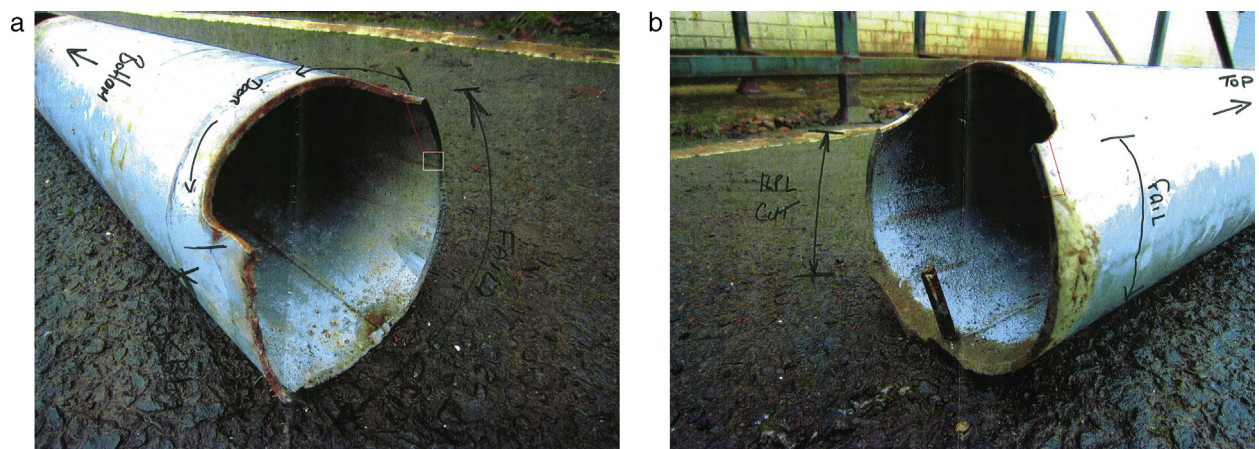
Fig. 2. Tubes cut from (a) the bottom and (b) the top parts of the damaged post (optical macro photographs of the regional fracture surfaces courtesy of the Department for Regional Development in Northern Ireland). The failed portion is labelled, as is the portion cut subsequently by angle grinder. The sampling locations are shown.

Also, the fact that the failure planes were so straight, shown in Fig. 2, would point to the previously existing surfaces or cracks. Galvanised zinc colour is even visible on the fractured surface in Fig. 2.

An even further proof of the pre-existing cracks is that the KPL cut surfaces, shown in Fig. 2, are much more heavily corroded, compared to the fracture surfaces, as the latter has zinc “protection” on them. In Fig. 2, the parts labelled “FAIL” is clean and straight, compared to the rusted and rough “KPL” side.

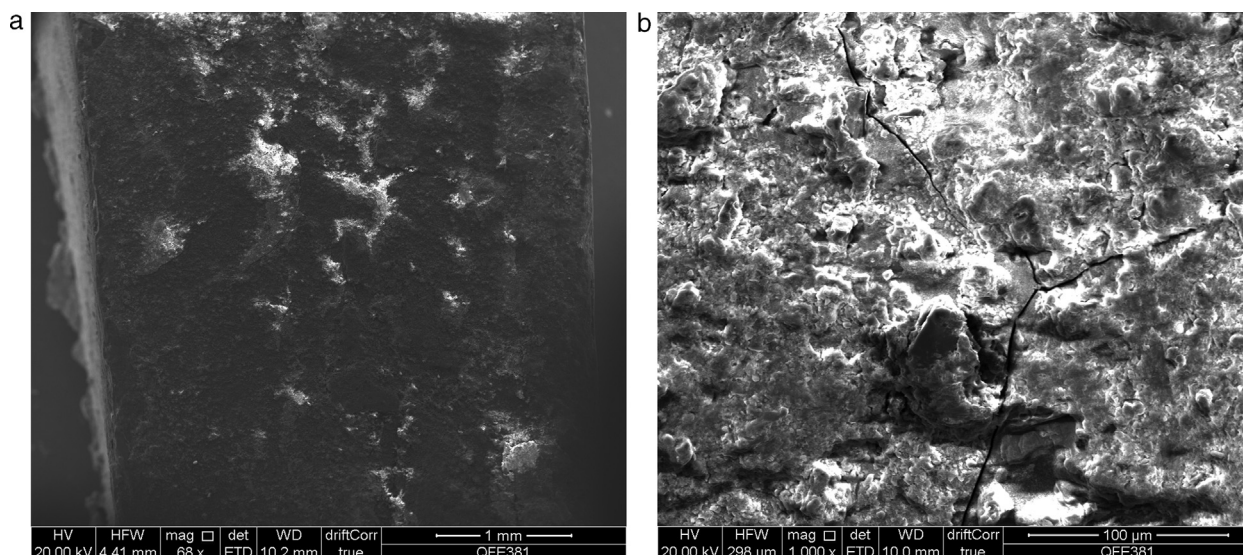
Fig. 3. Fracture surface from the bottom tube, at (a) low and (b) high magnifications as shown by the scale bar on bottom right of the images.

The fracture surface does not look like that for typical steels [1]. See SEM images in Fig. 3. Two fracture tube faces show a same morphology, so only one is shown in Fig. 3.

So, the cracks shown in Fig. 3b are cracks of ZnO, and are not necessarily cracks of steel, underneath the surface ZnO layer.

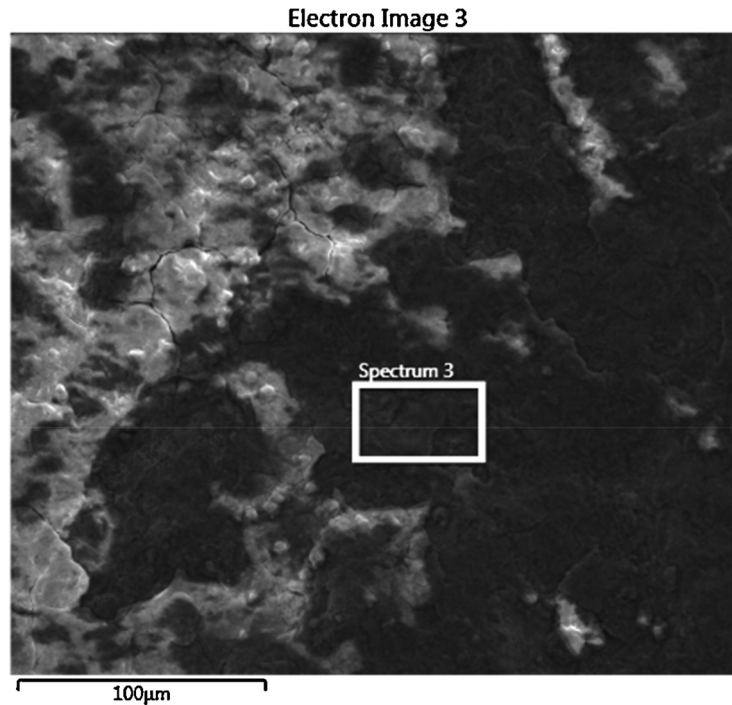
**Fig. 4.** Fracture surface from top tube, showing the local absence of the ZnO layer.

Some parts of the ZnO layer were broken or torn off, revealing the steel surface, partially corroded and darker upon imaging (Fig. 4). Chemical analysis showed that the exposed darker parts were mainly oxidised steel. For example, analysis of the area labelled Spectrum 3 in Fig. 4 gave a composition shown in Table 1. Note again that all chemical analyses given in the paper only show composition of the top few micrometres of the surface that we are looking at. So, the analysis of Spectrum 3 in Table 1 is likely result of a mixture of the residual zinc coating (very thin so the electrons could penetrate through) and the real steel underneath. Mn is from the bulk mild steel. Some dotted rust was seen by naked eye on this fracture surface, presumably due to the steel exposing after parts of the zinc layer were torn or broken off.

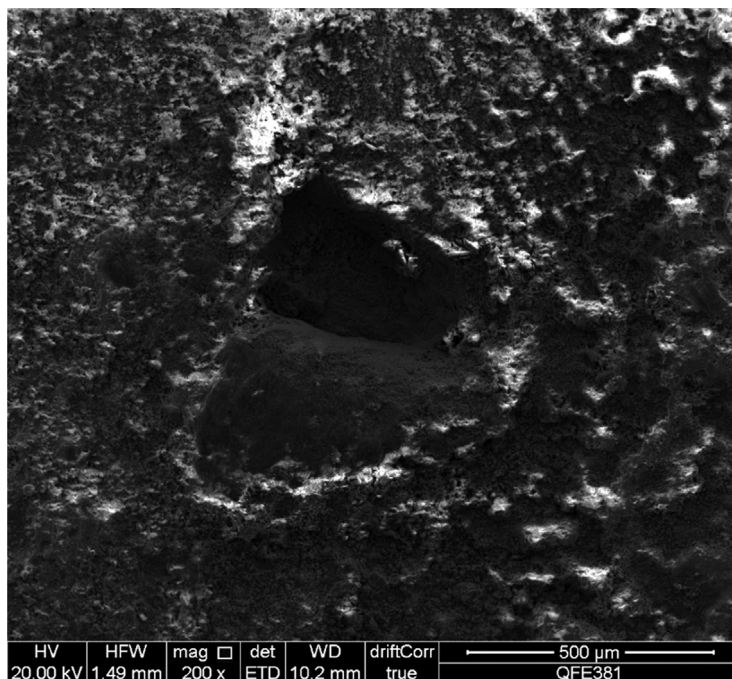
Fig. 5 shows vividly the tearing of the zinc layer, still attached to the rest on one side. The steel exposed in the hole would readily corrode, and may be one of the dotted rust spots (about 0.3 mm in size, in this case), when looking at this specimen with the naked eye.

Fig. 5. Tearing of the zinc layer.

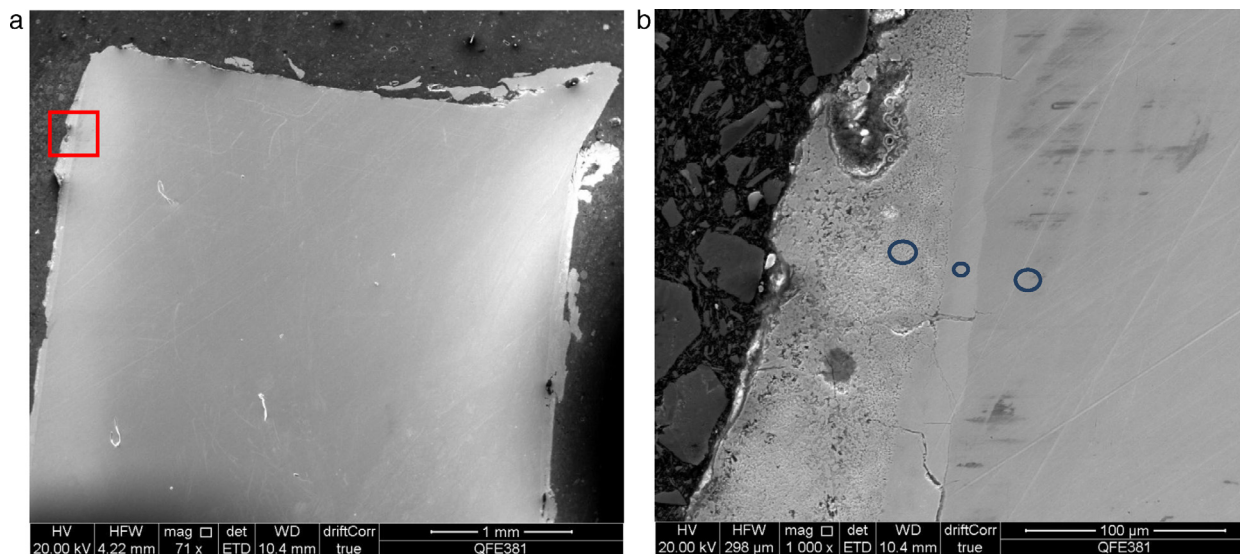
Fig. 6. Scanning electron micrographs of the longitudinal section. (a) Low magnification picture; (b) high magnification showing the zinc galvanised layers and areas for chemical analyses.

Fig. 6b shows galvanised inside tube wall. The outside tube wall, on the right hand side surface of Fig. 6a, would have similar features, but was not imaged. This figure shows galvanised zinc layers beautifully. The composition of the area marked by the left oval in Fig. 6b is 92%Zn, 6%Fe, 2%O. The composition of the area marked by the middle oval is 90%Zn, 8%Fe, 1%O. The composition of the area marked by the right oval is 99.5%Fe, 0.5%Mn, typical of mild steel. Electron microprobe cannot detect carbon when it is, say, 0.2%, as in mild steel. There are only three elements detected in the galvanised layers.

Such layered structure of galvanised zinc is typical. Note that this was from tube inside wall, and so should not be relevant to the fracture, but it serves as an identification of galvanised layer, and a calibration of the analysis.

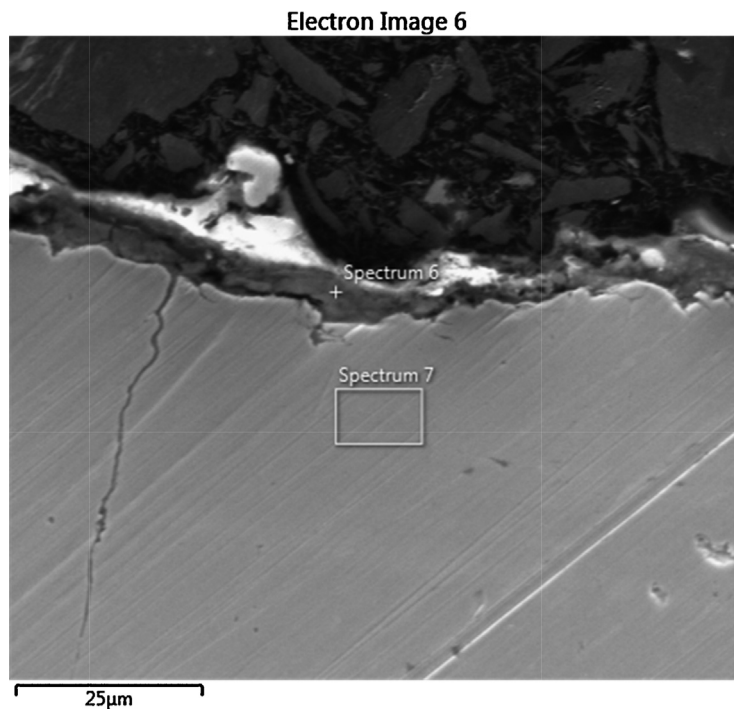
Fig. 7. Scanning electron micrograph of the longitudinal section, showing the cross-section of the fracture surface. Mounting resin is shown outside (top) the brighter specimen.

The zinc found on the fracture surface in Section 3.2 was verified when examining the longitudinal section of the fracture surface, i.e., the top surface shown in Fig. 6a, now magnified in Fig. 7. The result of the chemical analysis of the location marked “Spectrum 6” is included in Table 1. The analysis of the area marked “Spectrum 7” gave the composition of steel, Fe- $(1.2 \pm 0.3)\%$ Mn.

There are long cracks parallel to the tube walls, shown in Figs. 7 and 8. It is inevitable for tubes to have anisotropic features, in longitudinal and cross-sectional directions, due to rolling defects along the rolling, i.e., longitudinal, direction. The cracks shown in Figs. 7 and 8 reflect these defects in the rolling direction, i.e., the axial direction of the tube. However, it is also clear that the cracks are only at near fracture surface areas, so they must have been formed at the surface and propagated to under the surface, to considerable depth. It is like delamination, but initiating only at the fracture surface.

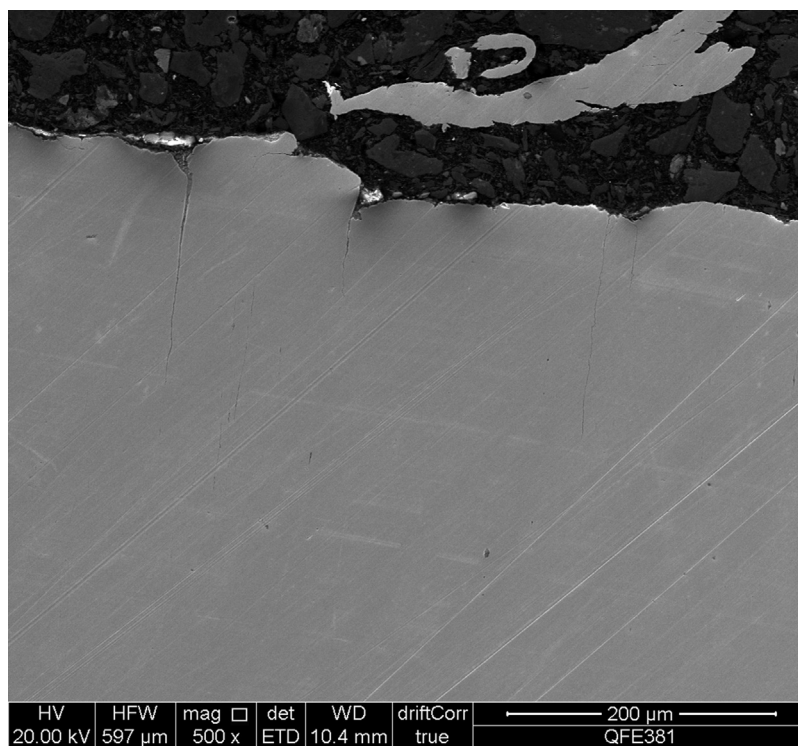
Fig. 8. Scanning electron micrograph of the longitudinal section. Mounting resin is shown outside (top) the brighter specimen. Ignore the small burr pieces at the top, separate from the main specimen. They were produced during longitudinal sectioning (cutting).
